**FINAL REPORT OF INVESTIGATION A&I E18345**

Arcing event

W-0020

<b>Date of Event:</b>	August 14, 2018
<b>Type of Event:</b>	Fire/Smoke
<b>Incident Time:</b>	01:45 hrs.
<b>Location:</b>	Alexandria Yard - Traction Power Sub-station (C99-TPSS)
<b>Time and How received by SAFE:</b>	01:45 hrs. via Safety Hotline
<b>Safety Officer Response:</b>	Yes
<b>Time of Safety Officer Arrival:</b>	05:56 hrs.
<b>Time of Safety Officer Departure:</b>	07:30 hrs.
<b>Rail Vehicle:</b>	N/A
<b>Injuries:</b>	None
<b>Damage:</b>	Yes – DC Circuit Breakers, Rectifiers
<b>Emergency Responders:</b>	SAFE, Alexandria Fire Department (AFD), POWER, ATC, RTRA, MTPD

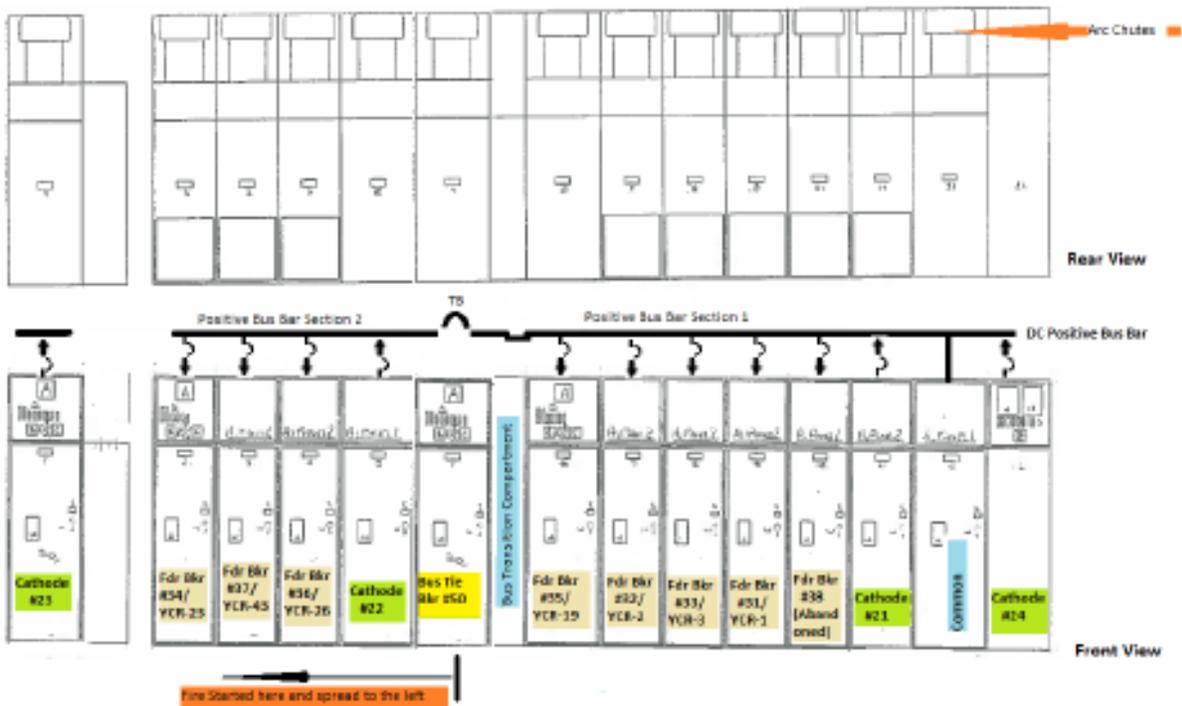
Figure-1, C99 TPSS DC Switchgear Lineup

**NOTE:** It appears that the fire started inside the Bus Tie Breaker 50 cubicle and spread to the adjacent cubicles and breakers which are also connected to the second section of the positive bus-bar as shown in Figure-1. Thus, the DC Cathode Breaker 22 cubicle is more damaged than the adjacent DC Feeder Breaker 36 and its cubicle. The severity is less on DC Feeder Breaker 34 and its cubicle than DC Feeder Breaker 37 and its cubicle. In general, all the DC breaker cubicles connected to the second section of the positive bus-bar and four breakers were damaged beyond repair (Picture 1-8). The fire also damaged control cables on the cable tray right above the burned switchgear, and there is also a visible smoke on the 4” conduit that runs from the Transformer Feeder Breaker 12 AC switchgear to Transformer 2 (Picture 9 and 10).

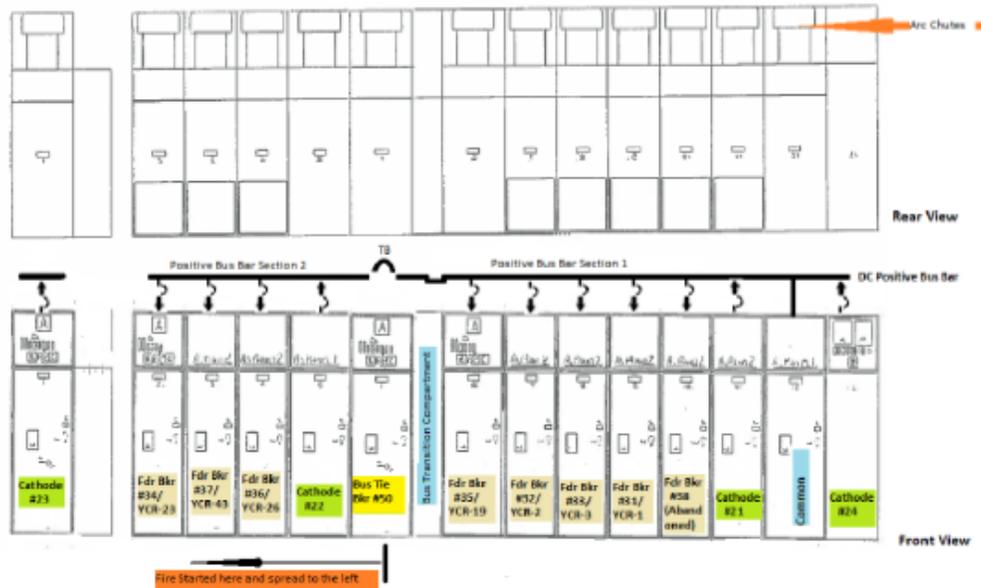
Figure-1, C99 TPS DC Switchgear Lineup

It appears that the fire started inside the Bus Tie breaker #50 cubicle and spread to the adjacent cubicles and breakers which are also connected to the second section of the positive bus bar as shown on *Figure-1*. Thus, DC cathode breaker, Breaker #22 cubicle is more damaged than the adjacent DC Feeder breaker #36 and its cubicle. The severity is less on DC Feeder Breaker #34 and its cubicle than DC Feeder Breaker #37 and its

cubicle. In general, all the dc breakers cubicles connected to the second section the positive bus bar and four breakers were damaged beyond repair, (Picture 1-8).

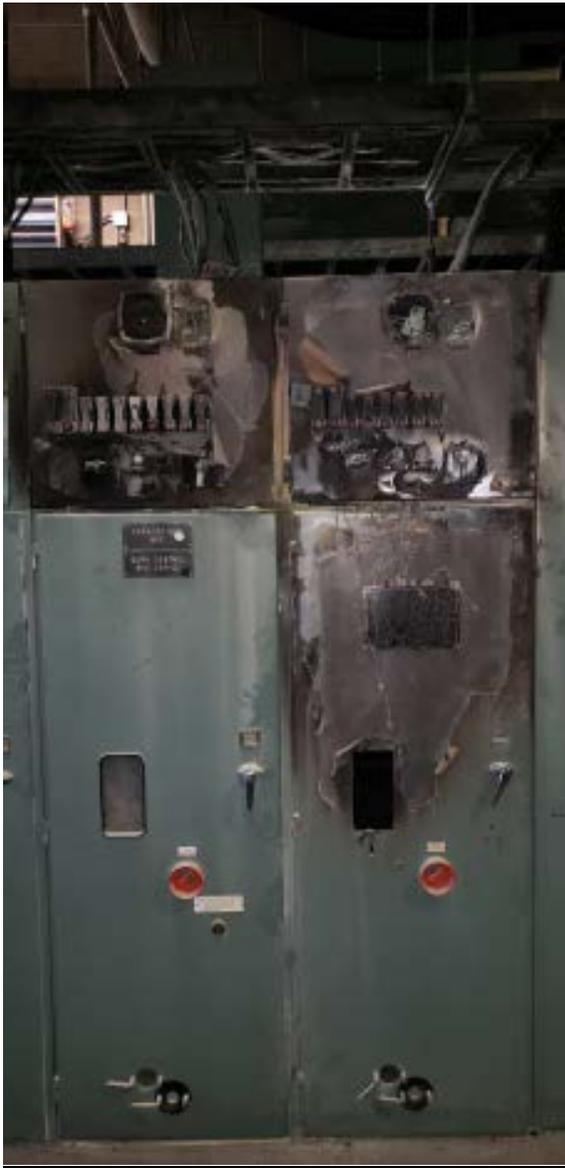
Picture 2 - C99 DC Breaker 50 and 22 Switchgears

Per POWER personnel, at C99 TPSS, the fire completely burned two Breaker Cubicles and caused damage to three additional Breaker Cubicles on the same section of the positive bus-bar. The two completely damaged Breaker Cubicles, (C99-22 and C99-50), were the “Cathode Breaker 22” and the “Positive to Positive Bus Tie Breaker 50” and their corresponding breakers, see Picture 2. Forensic inspection revealed that failed breakers

The two completely damaged cubicles, (C99-22 and C99-50), are the "Cathode Breaker #22" and the "Positive to Positive Bus Tie Breaker #50" and their corresponding breakers, see *Picture-2*.

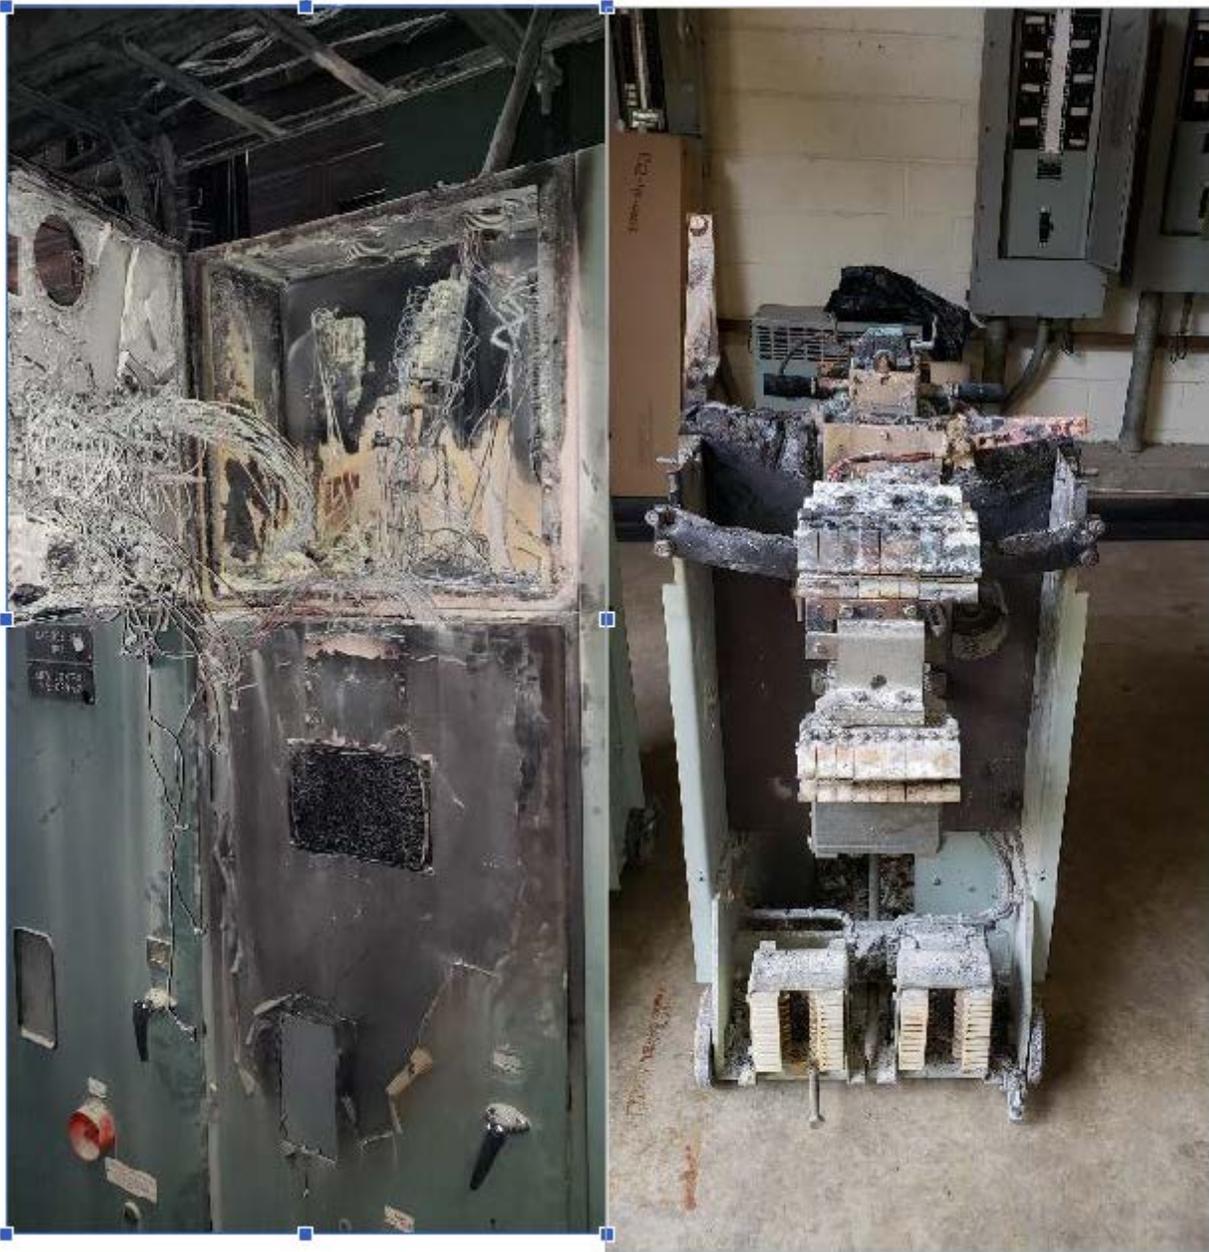
Picture 3 - C99 DC Breaker 50 Switchgear Cable Compartment and Breaker

- It appeared that the DC Bus Tie Breaker, breaker 50 arc chute was completely burned by the fire due to excessive arcing during the arc interruption in the arc chute, (Picture 3 and 4). The fire may have been ignited by flammable dust and ionized metal particles in the presence of ionized air, inside a 40-year-old arc chute.

It appeared that DC Bus Tie Breaker, breaker #50 arc chute was completely burned by the fire created due to excessive arcing during the arc interruption in the arc chute, (*Picture 3&4*). The fire may be ignited by flammable dust and ionized metal particles in the presence of an ionized air, inside a 40-year-old arc chute.

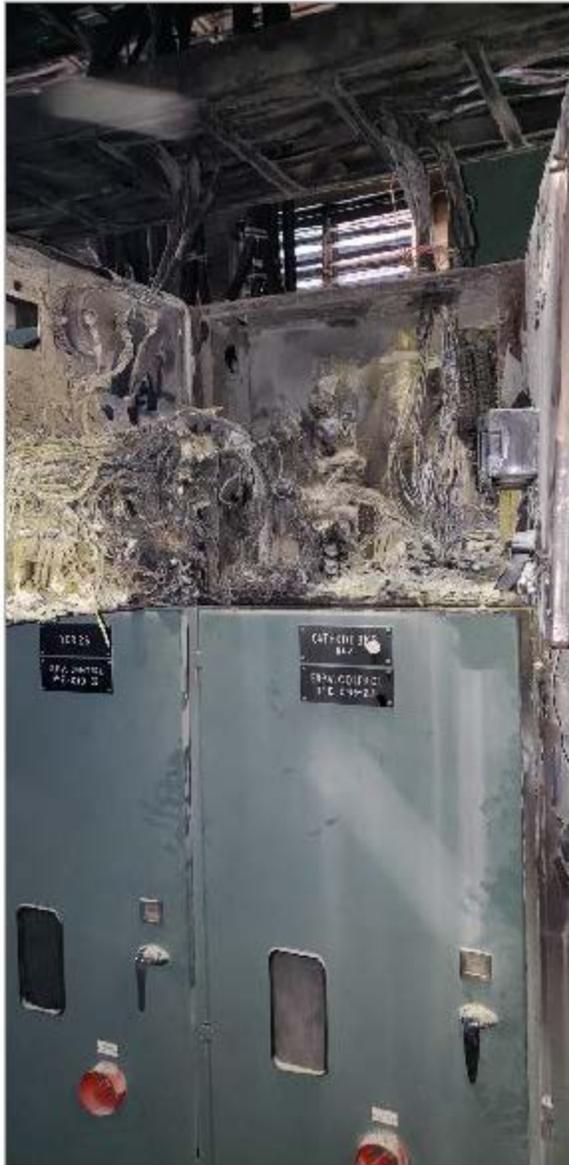
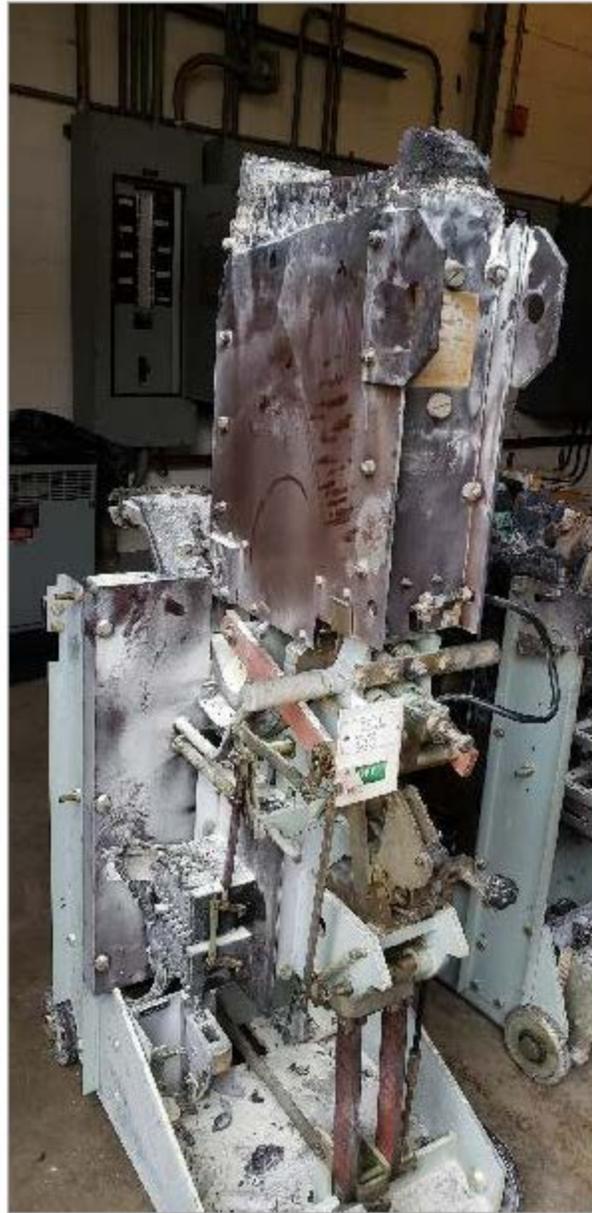
Picture 4 - C99 DC Breaker 22 Switchgear Cable Compartment and Breaker

- Before Breaker 50 arc chute was completely burned, the fire and the extreme heat it created was puffed out of its chimney vent and spread to the adjacent cathode breaker 22. The heat and flames also damaged the above cable tray containing

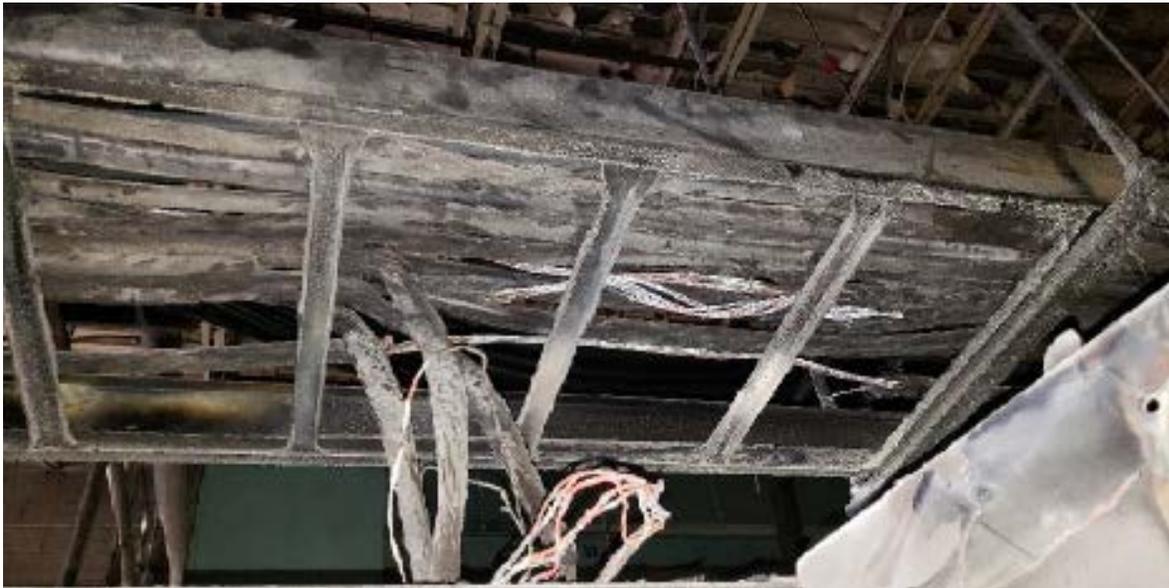
Picture 6 - C99 DC Switchgear Control Cables & Cable Tray

control wires (Picture 6). It also appears that the fire inside the wiring compartment of these cubicles, which enclosed breaker 50 and 22, was ignited and totally burned by the intense heat on the back of the metal enclosed control wiring compartment, which first started by melting the control wire insulation and then caught fire.

Before Breaker #50 arc chute was completely burned, the fire and the extreme heat it created was puffed out of its chimney vent and spread to the adjacent cathode breaker #22. The heat and flames also damaged the above cable tray containing control wires (*Picture 9*). It also appears that the fire inside wiring compartment of these cubicles, which enclosed breaker #50 and #22, was ignited and totally burned by the intense heat on the back of the metal enclosed control wiring compartment, which first start by melting the control wire insulation and then catch fire.

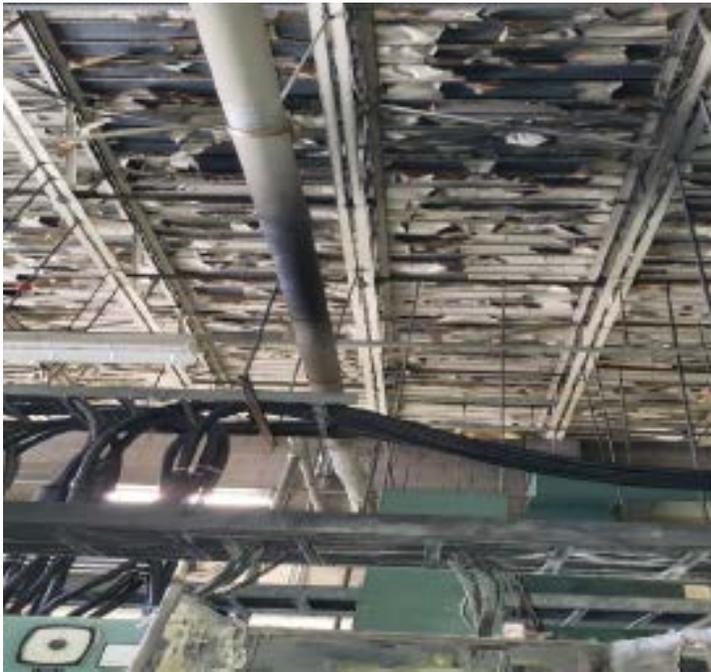
Picture 7 - C99 Transformer 2 Feeder Cable Conduit

The fire also damages control cables on the cable tray right above the burned switchgears, and there is also a visible smoke on the 4" conduit that runs from the Transformer feeder breaker #12 AC switchgear to Transformer #2 (Picture 9 & 10).
